New Hampshire Volunteer Lake Assessment Program

2003 Biennial Report for Sunrise Lake Middleton

NHDES
Water Division
Watershed Management Bureau
29 Hazen Drive
Concord, NH 03301

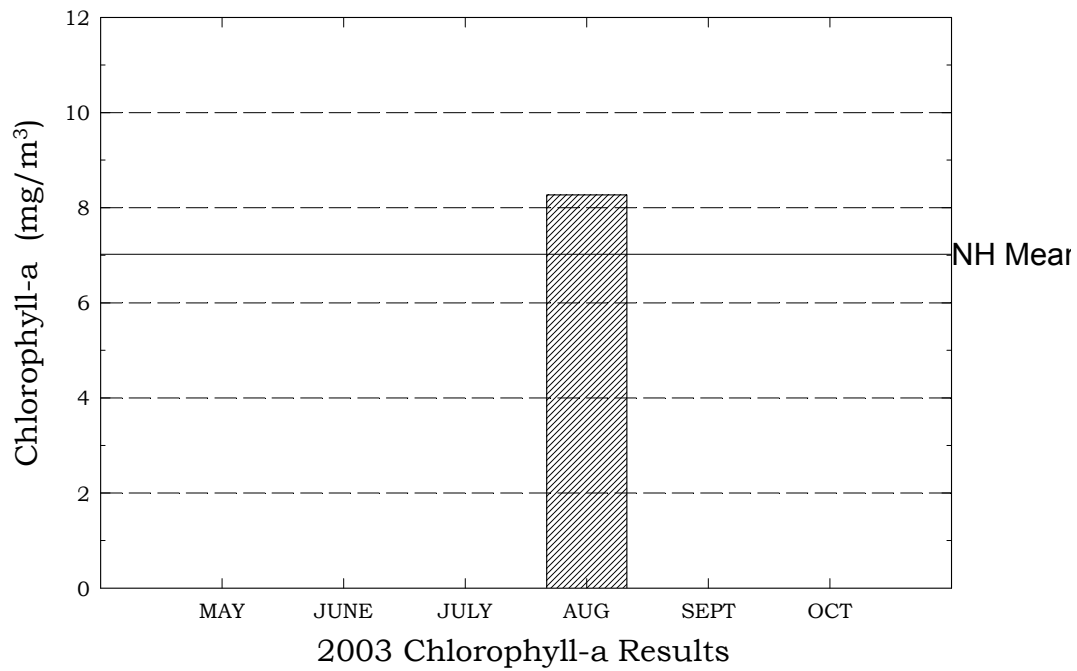
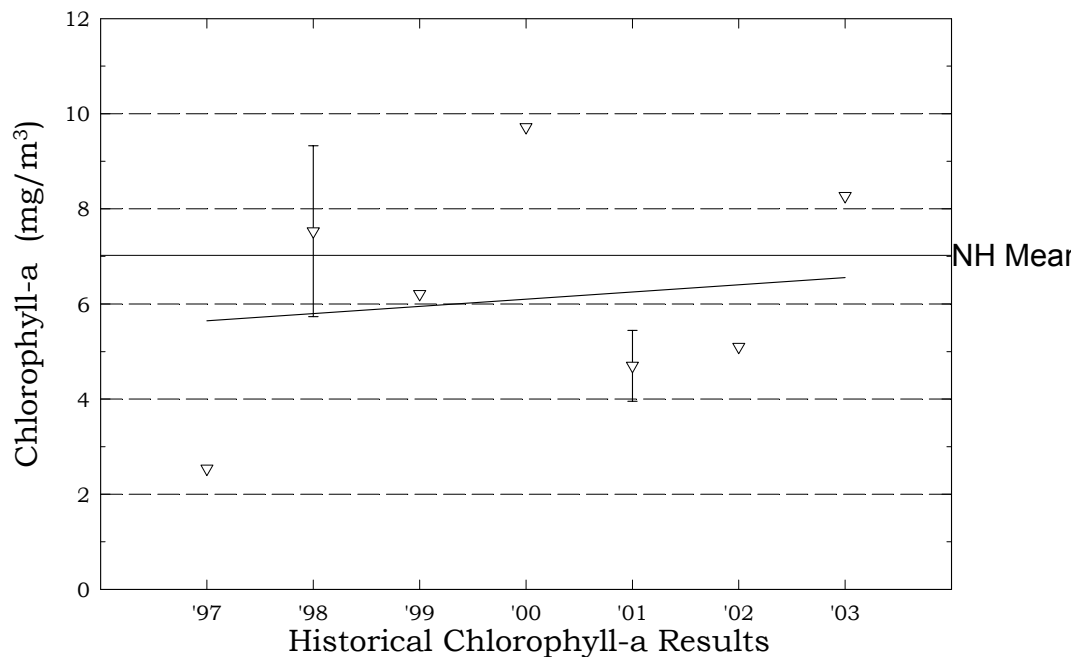
Figure 1. Monthly and Historical Chlorophyll-a Results

The current year data (the top graph) show that the chlorophyll-a concentration in August was **greater than** the state mean.

The historical data (the bottom graph) show that the 2003 chlorophyll-a mean is **greater than** the state mean.

Overall, visual inspection of the historical data trend line (the bottom graph) shows **a variable** in-lake chlorophyll-a trend, meaning that the concentration has **fluctuated** since monitoring began. After 10 consecutive years of sample collection, we will be able to conduct a statistical analysis of the historic data to objectively determine if there has been a significant change in the annual mean chlorophyll-a concentration since monitoring began. Collecting more samples each year will likely provide data that are more consistent.

- **Figure 1 and Table 1:** The graphs in Figure 1 (Appendix A) show the historical and current year chlorophyll-a concentration in the water column. Table 1 (Appendix B) lists the maximum, minimum, and mean concentration for each sampling season that the lake has been monitored through the program.

While algae are naturally present in all lakes/ponds, an excessive or increasing amount of any type is not welcomed. In freshwater lakes/ponds, phosphorus is the nutrient that algae depend upon for growth. Algal concentrations may increase with an increase in nonpoint sources of phosphorus loading from the watershed, or in-lake sources of phosphorus loading (such as phosphorus releases from the sediments). Therefore, it is extremely important for volunteer monitors to continually educate residents about how activities within the watershed can affect phosphorus loading and lake/pond quality.

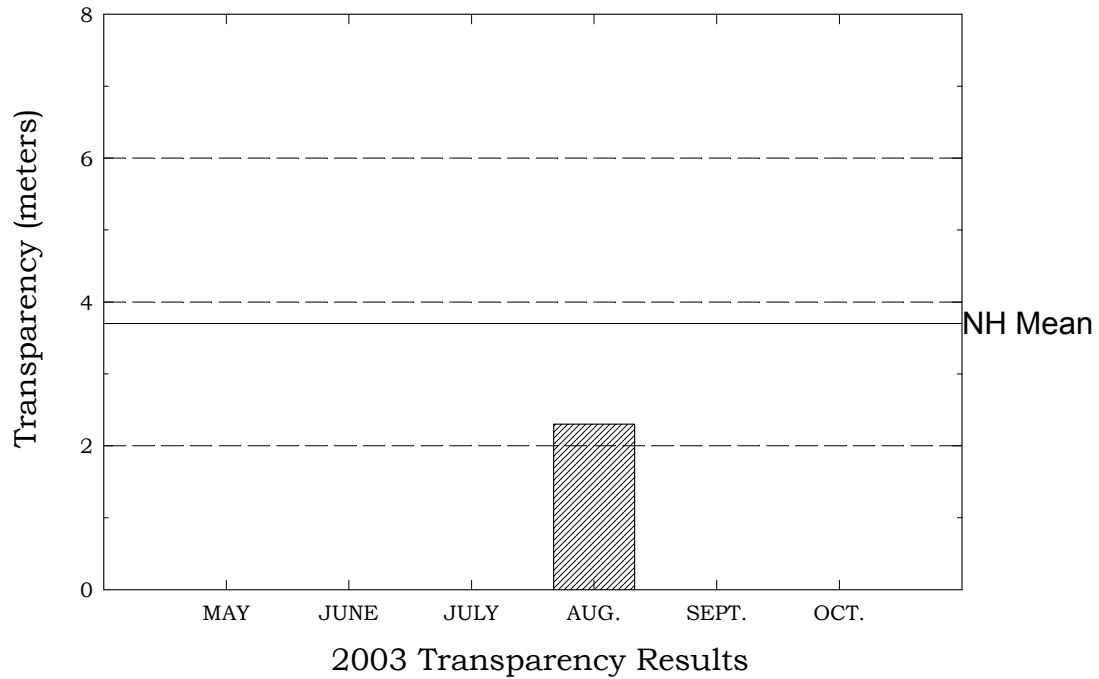
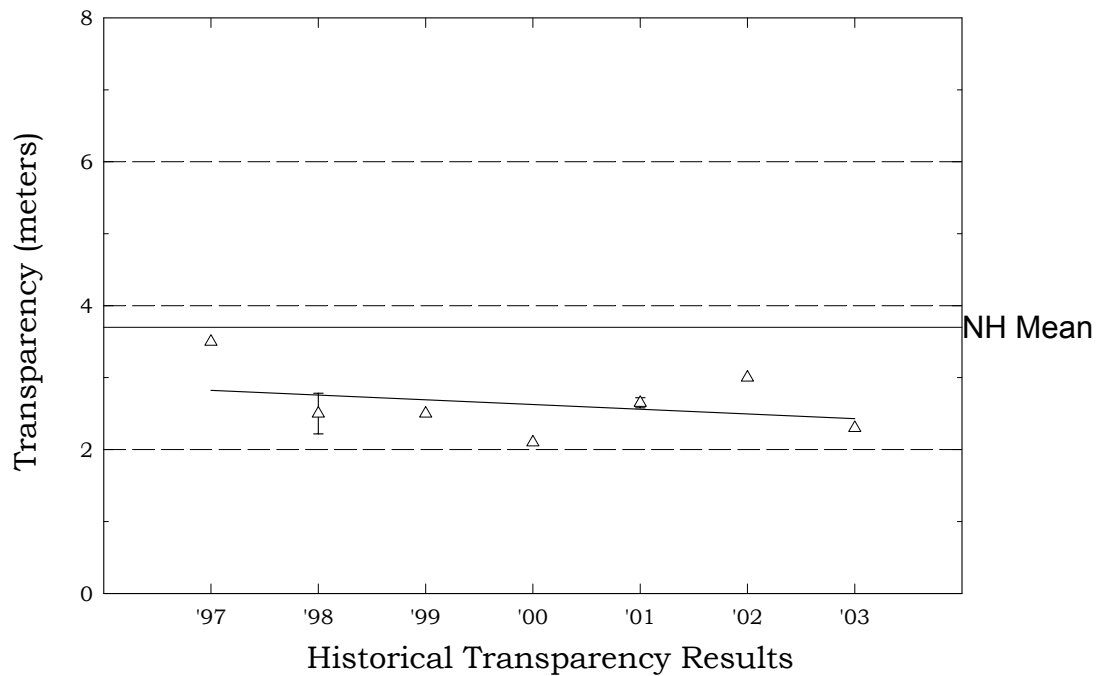
Figure 2. Monthly and Historical Transparency Results

The current year data (the top graph) show that the in-lake transparency in August was **less than** the state mean.

The historical data (the bottom graph) show that the 2003 mean transparency is **less than** the state mean.

Overall, visual inspection of the historical data trend line (the bottom graph) shows **a stable** trend for in-lake transparency, meaning that the transparency has **remained approximately the same** since monitoring began. After 10 consecutive years of sample collection, we will be able to conduct a statistical analysis of the historic data to objectively determine if there has been a significant change in the annual mean transparency since monitoring began.

- **Figure 2 and Table 3:** The graphs in Figure 2 (Appendix A) show historical and current year data for lake transparency. Table 3 (Appendix B) lists the maximum, minimum and mean transparency data for each sampling season that the lake has been monitored through the program.

Typically, high intensity rainfall causes erosion of sediments into lakes/ponds and streams, thus decreasing clarity. Efforts should continually be made to stabilize stream banks, lake shorelines, disturbed soils within the watershed, and especially dirt roads located immediately adjacent to the edge of tributaries and the lake. Guides to Best Management Practices designed to reduce, and possibly even eliminate, nonpoint source pollutants, such as sediment loading, are available from DES upon request.

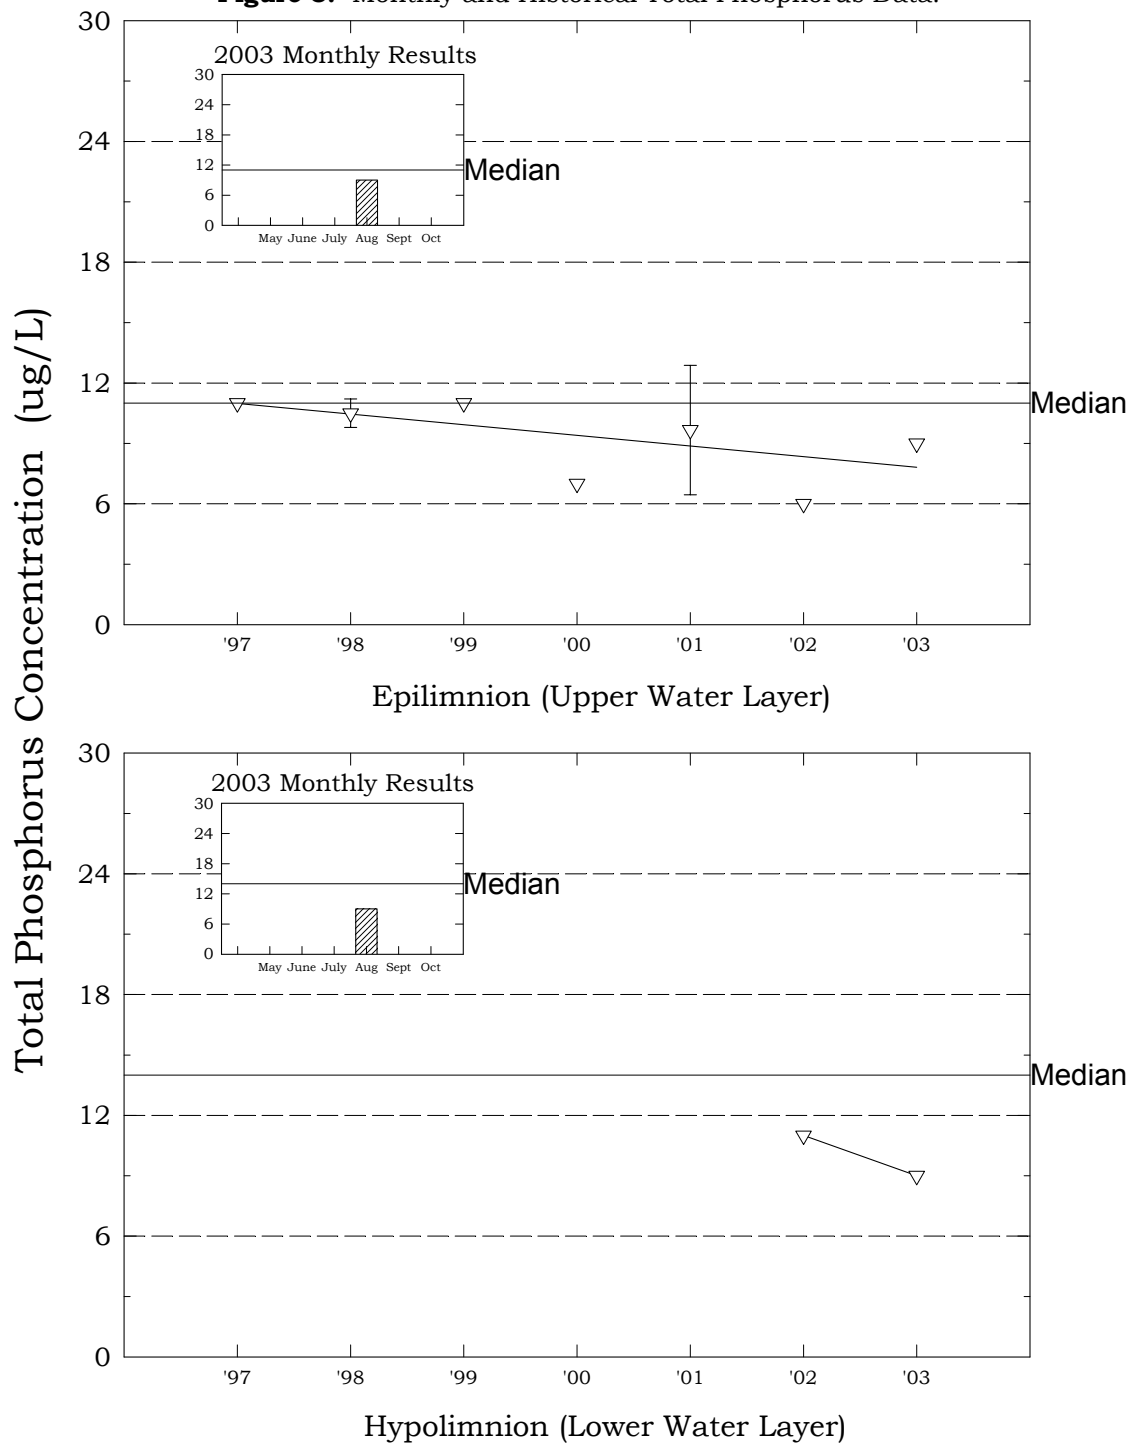
Figure 3. Monthly and Historical Total Phosphorus Data.

The current year data for the epilimnion (the top inset graph) show that the phosphorus concentration in August was **less than** the state median.

The historical data show that the 2003 mean epilimnetic phosphorus concentration is **less than** the state median.

The current year data for the hypolimnion (the bottom inset graph) show that the phosphorus concentration in August was **less than** the state median.

The historical data show that the 2003 mean hypolimnetic phosphorus concentration is **less than** the state median.

Overall, visual inspection of the historical data trend line for the epilimnion shows **a relatively stable** phosphorus trend, which means that the concentration has **remained approximately the same** in the epilimnion since monitoring began.

Overall, visual inspection of the limited historical data for the hypolimnion shows **a slightly decreasing** phosphorus trend, which means that the concentration has **improved** in the hypolimnion since monitoring began.

- **Figure 3 and Table 8:** The graphs in Figure 3 (Appendix A) show the amounts of phosphorus in the epilimnion (the upper layer) and the hypolimnion (the lower layer); the inset graphs show current year data. Table 8 (Appendix B) lists the annual maximum, minimum, and median concentration for each deep spot layer and each tributary since the lake joined the program.

One of the most important approaches to reducing phosphorus loading to a waterbody is to continually educate watershed residents about its sources and how excessive amounts can adversely impact the ecology and value of lakes and ponds. Phosphorus sources within a lake or pond's watershed typically include septic systems, animal waste, lawn fertilizer, road and construction erosion, and natural wetlands.
